Dynamic Load Tests at drilled shafts in sandy soil deposits to bedrock, Central Pacific, Costa Rica: strategic learnings for the construction methods.

Abstract

1 Introduction

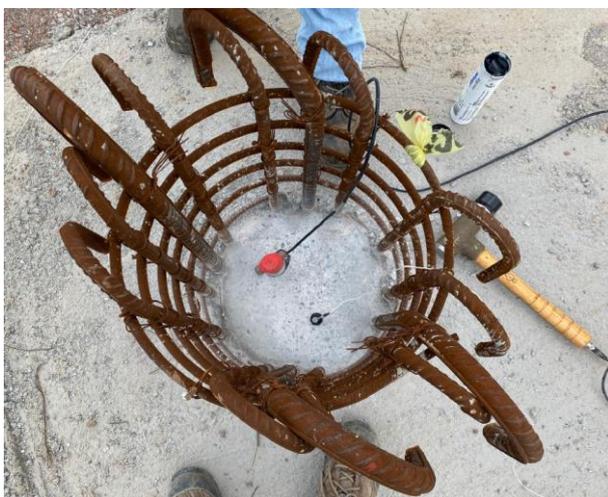
Figure 2. PIT equipment used for integrity testing

This is required on the wave equation analysis pile model, since the signal matching on the DLT needs a rational distribution of the shaft diameter for accurate calculations. On *Figure 2* it could be seen the equipment used for the PITs.

In this case a double measure was employed, an accelerometer of high sensitivity and a redundant geophone, as shown in the previous figure.

PITs were executed as part of the quality control, but also to evaluate the location of possible bulges and contractions on the pile diameter.

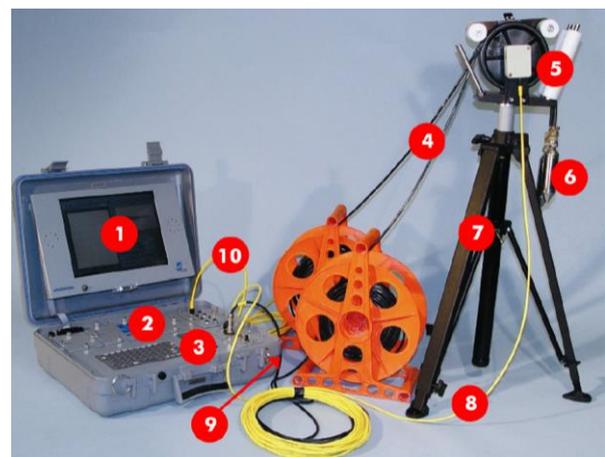
Figure 3. CSL equipment used for integrity testing

For the CSL testing it was used the equipment presented on *Figure 3* that includes:

- Central computer and data acquisition (1-3)
- Instrumented pulley to measure depth (5)
- Two hydrophones (6)
- Cables (4,8,9,10)

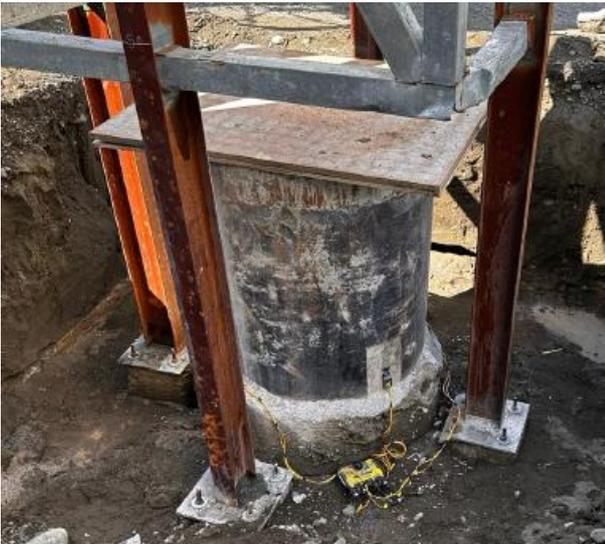
Figure 4. Pile head preparation PDA and sensors

The DLTs were performed with a pile driving analyser (PDA), that collects the waves information from (3) strain gauges on a 120° pattern to cover the shaft perimeter and (1) accelerometer.

The pile head preparation (Steel plate to avoid concrete spalling and plywood sheet to distribute the blow on the head), the PDA and (2) sensors are shown on *Figure 4*.

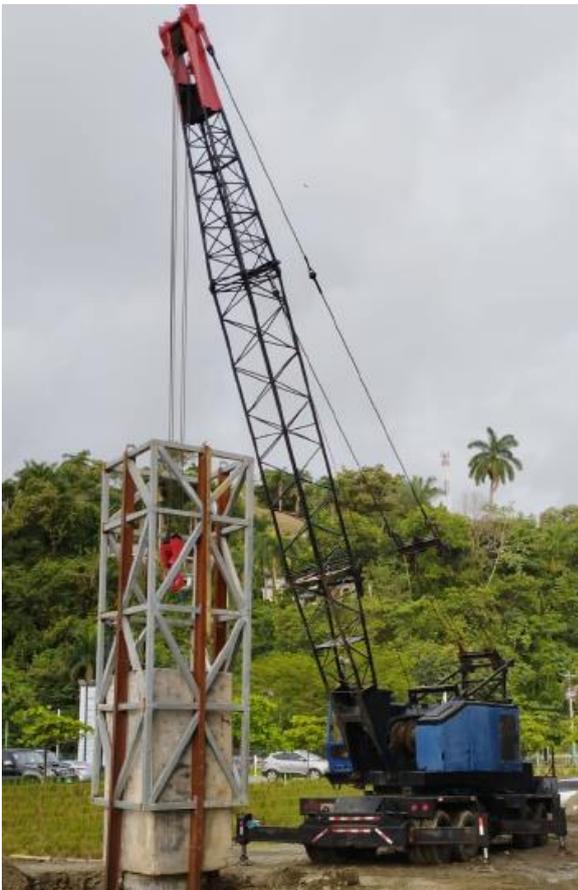
Figure 5. Weight, guide and crane for DLT

To provoke the high strain wave for the test a fabricated weight of about 20 Ton was used. A lattice crane lift and then free fall the weight onto the pile head.

To control the mass fall, a steel guide was placed and centred on the pile to avoid uneven blows and for safety. On *Figure 5* it could be seen the arrangement of the pile, guide and weight used on the tests.

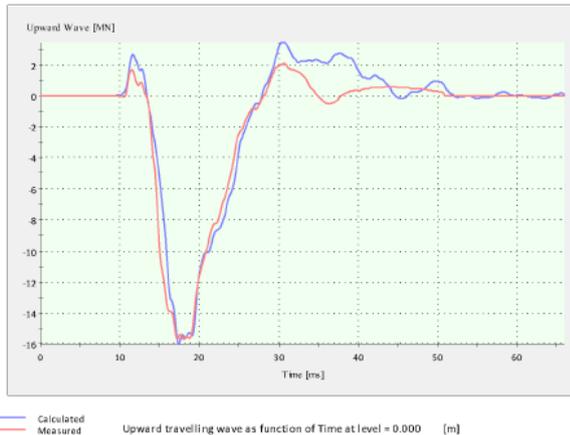
Figure 10. Free end response on WU of test pile

The (3) piles in which the CSL denotes a defect on the bottom had a behavior on the wave up (WU) that denote free end (no toe reaction), *Figure 10*.

Hence, there is a clear correlation between the results from the CSL and the DLT. The difference between free and fixed end is the valley shown on the free-end case, which denotes negative velocity and low force at bottom.

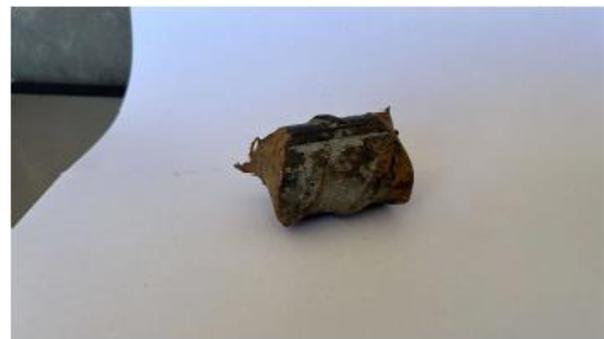
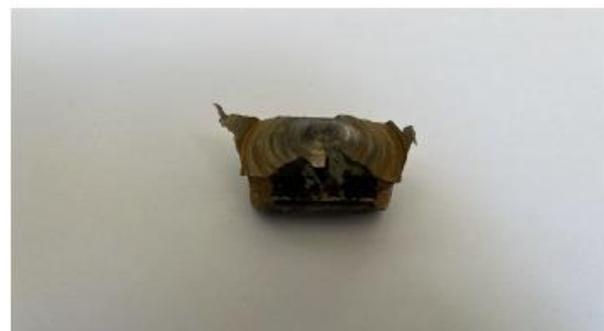
Figure 12. Steel rebar recovered from pile core

From the inside core, there were 0.9 m with neither concrete nor rock recover. Interestingly, the rotation cut some clean steel rebars from the toe, denoting a longer pile length that the obtained from cores (See Figure 12).

To further investigate this behaviour, it was decided to drill and extract (2) concrete cores: (1) through the centre of one of the existing shafts with defects, but also (1) outside the same pile.
